AFFIDAVIT OF MICHAEL CANNON

March 11, 2019

RE: Ms. Janice Scott- Insured
1590 Foote Street NE
Atlanta, Georgia 30307
Claim No. HL95871
Water Damage Causation Investigation
Forcon No. G19336

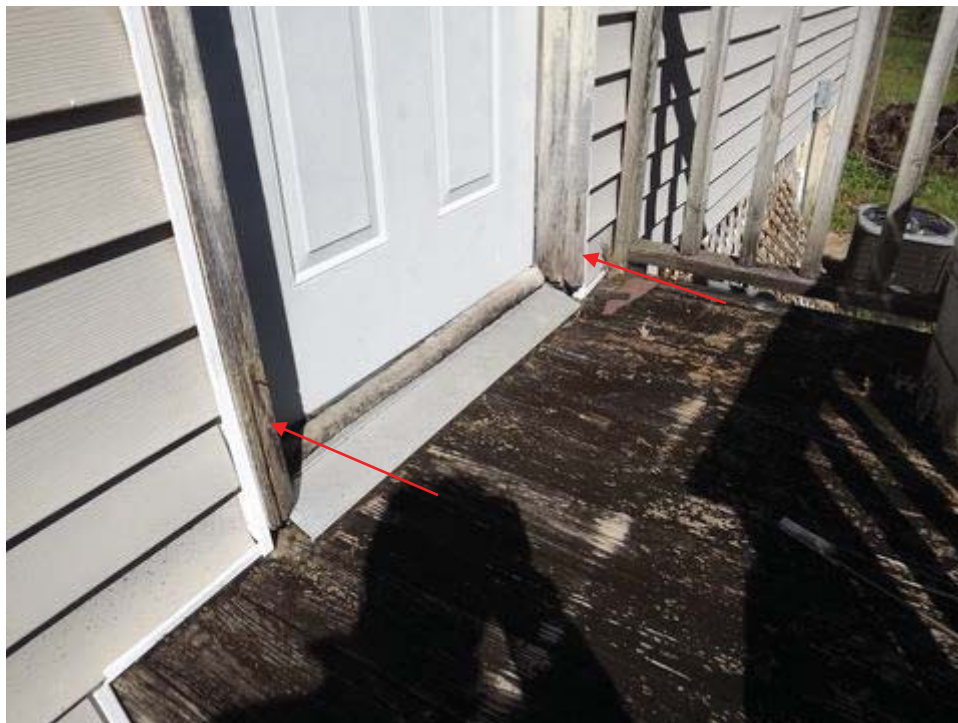
- 2) The house was in a state of disrepair. The exterior door frame molding to the side entry door to the kitchen was severely weathered and had visible wood rot at the base of both sides of the door frame. An exterior door threshold had been added to drain rainwater away from the base of the exterior metal door. The base of the metal door was rusted primarily on the interior (kitchen) side indicating long-term water exposure and likely water infiltration into the kitchen. There was an area of vinyl siding that had been repaired (~ 4 x 6") on the back exterior wall using duct tape. However, the duct tape had deteriorated and exposed the foam board sheathing beneath it to the weather.

Photograph 2- Side Entry Door to Kitchen with Weathered Door Frame Molding

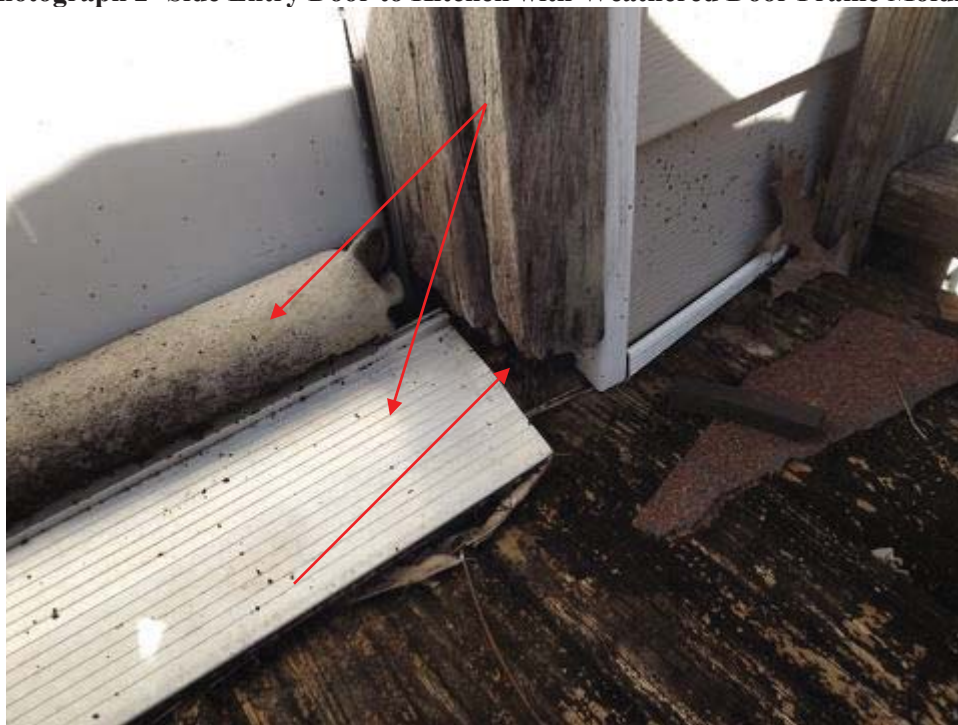
Based on my training and experience, wood rot on the door frame molding and rust on the interior side of the metal door's base indicate years of exposure to rainwater.

Photograph 3- Right Side of Door Frame Molding Shown in Photo 2 with Visible Wood Rot- Note: Door Threshold and Door Threshold Draft Cover

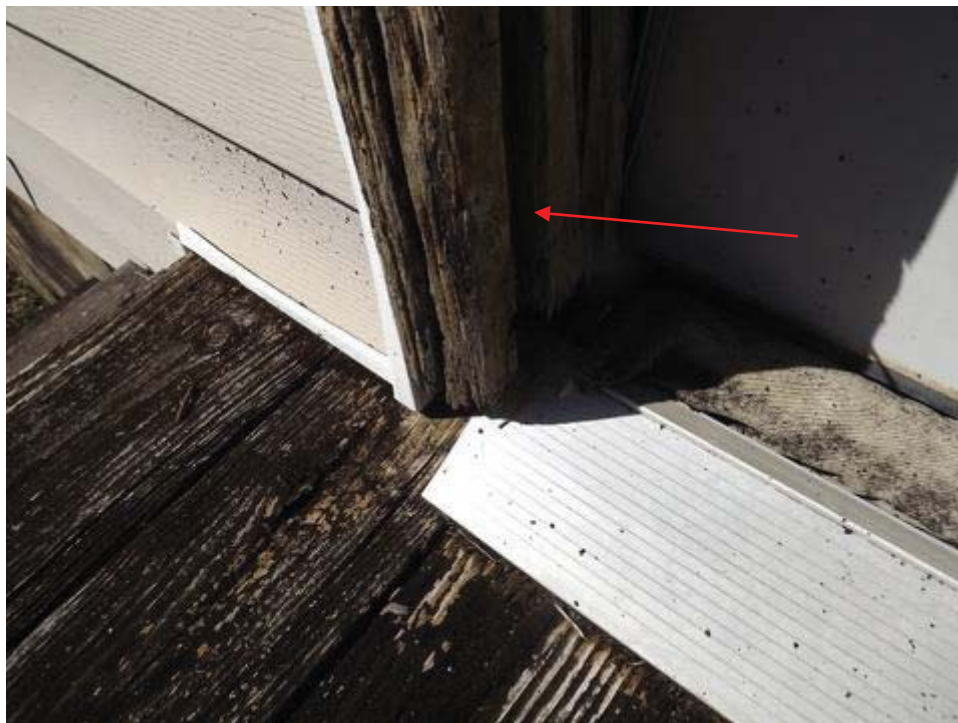
Photograph 4- Wood Rot on Left Side of Door Shown in Photo 2

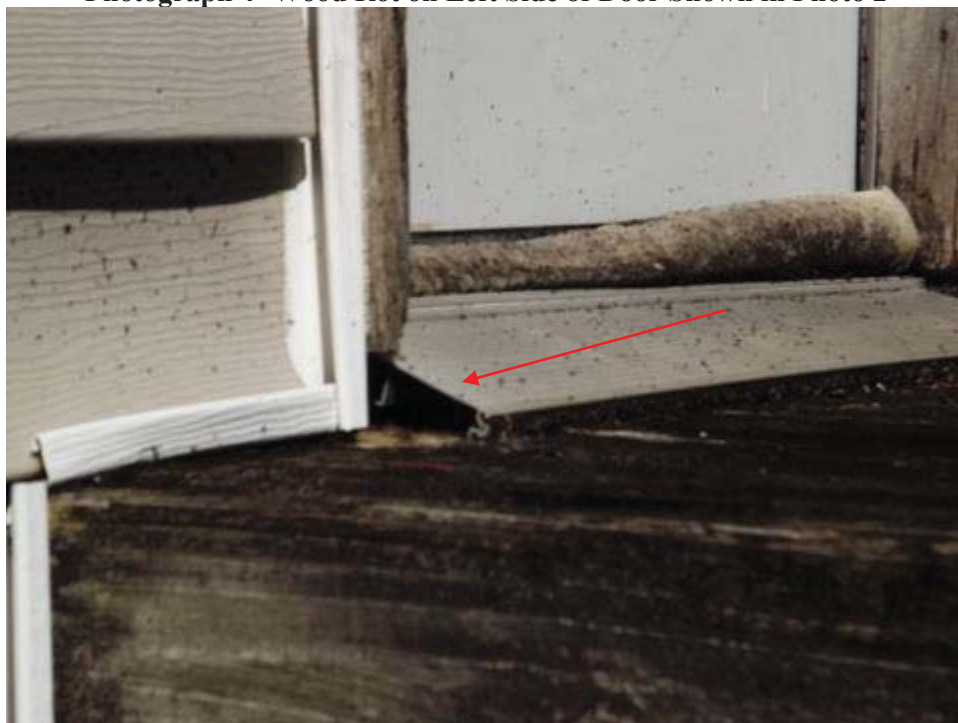
Photograph 5- View of Raised Door Threshold to Divert Rainwater Away from Base of Entry Door Shown in Photo 2

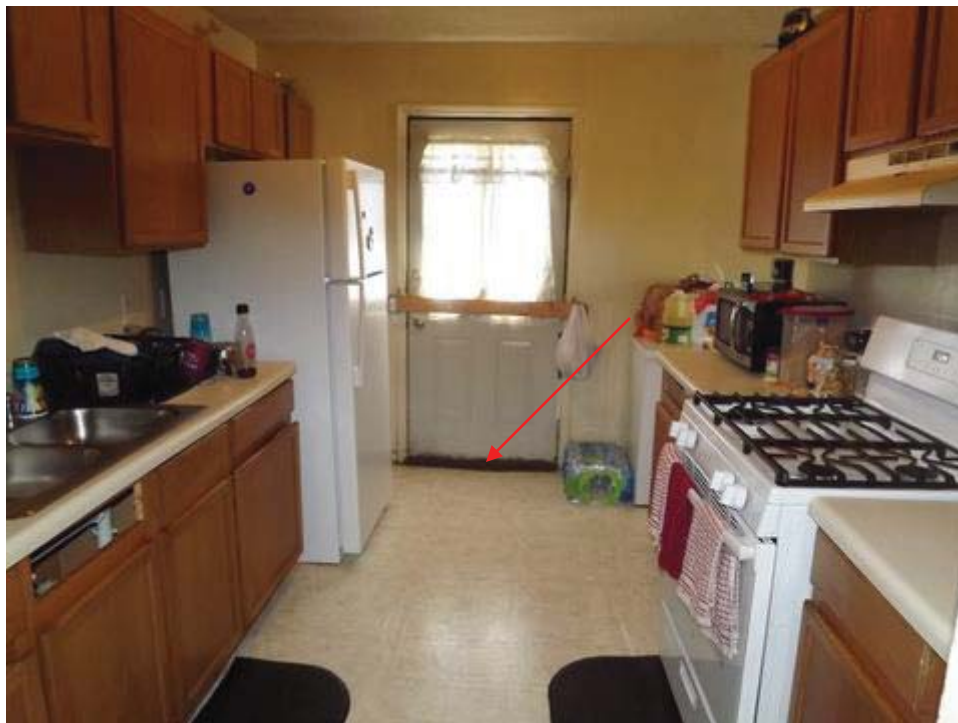
Photograph 6- Visible Rust at Base of Side Entry Door Shown in Photo 2

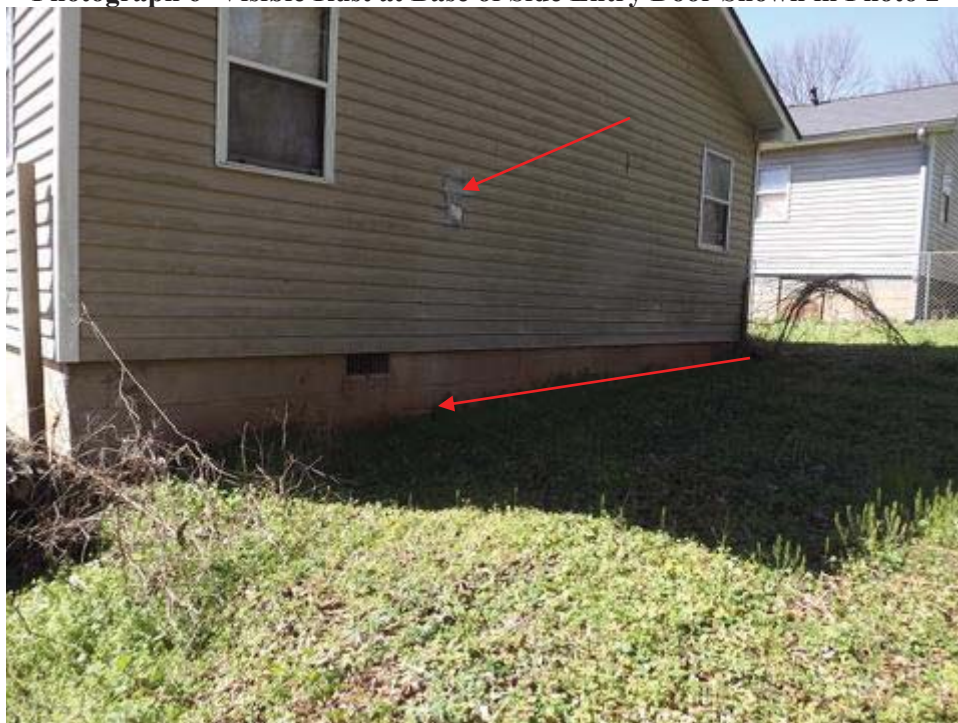
Photograph 7- East (Left) and North (Right) Corners of the Hose- Note: Slope of Grade and Repaired Area of Vinyl Siding

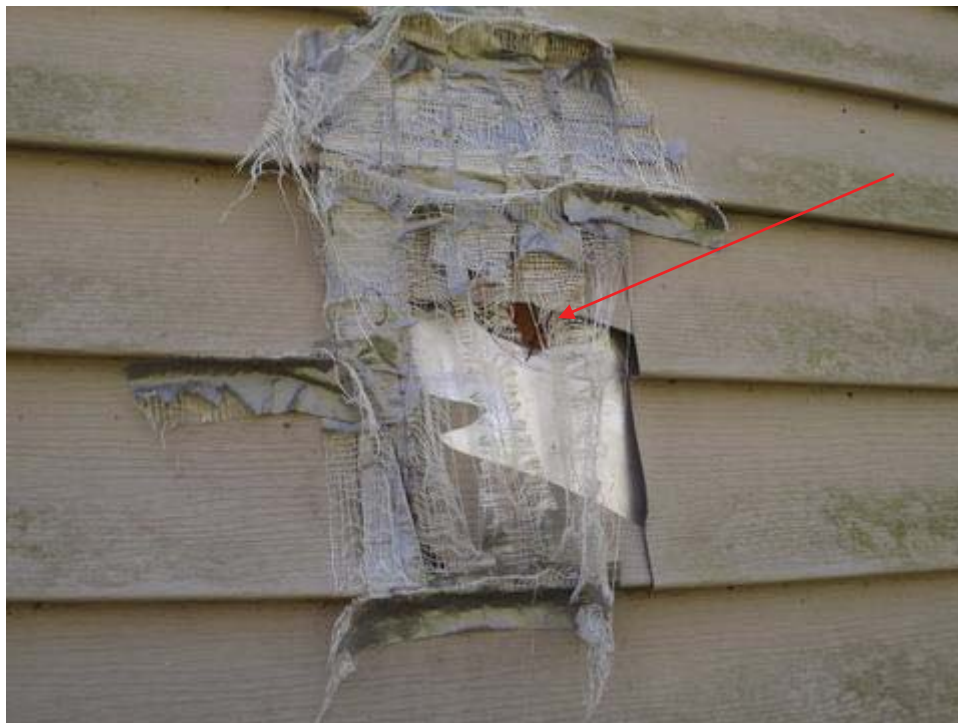
Photograph 8- Closer View of Deteriorated Repair of Vinyl Siding Shown in Photo 7

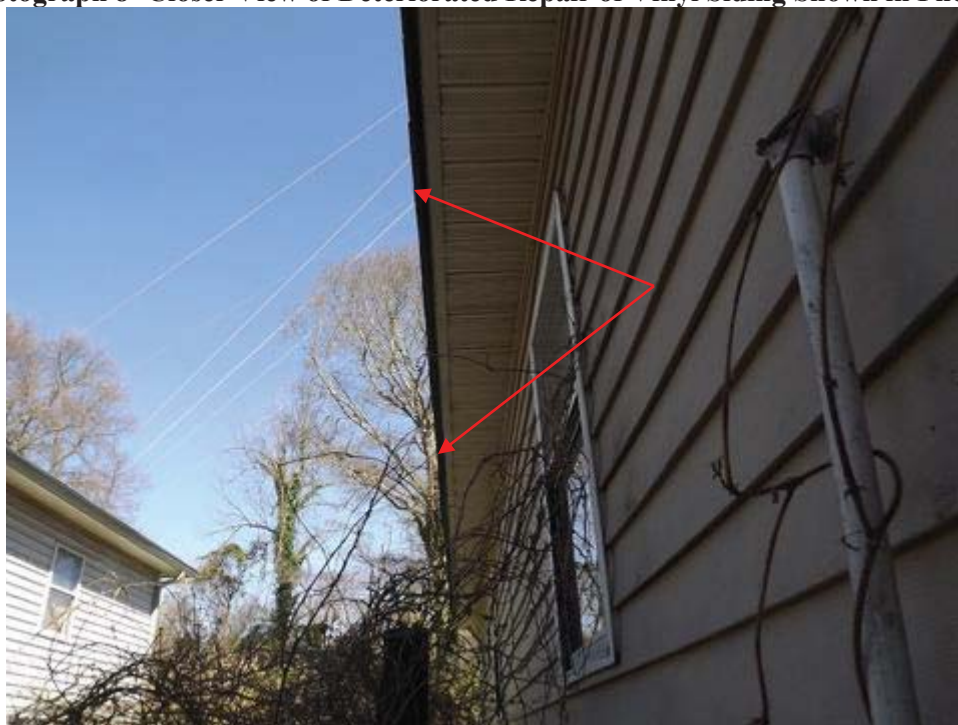
The exterior finishes included vinyl lap siding, perforated vinyl soffits/eaves and three tab fiberglass shingles laid over a gabled roof. The eaves were not guttered and allowed rainwater from the roof to run-off directly next to the foundation. There was a covered front porch and a side entry porch constructed of pressure treated lumber.

Photograph 9- View of North/Northwest Side of House With No Gutters

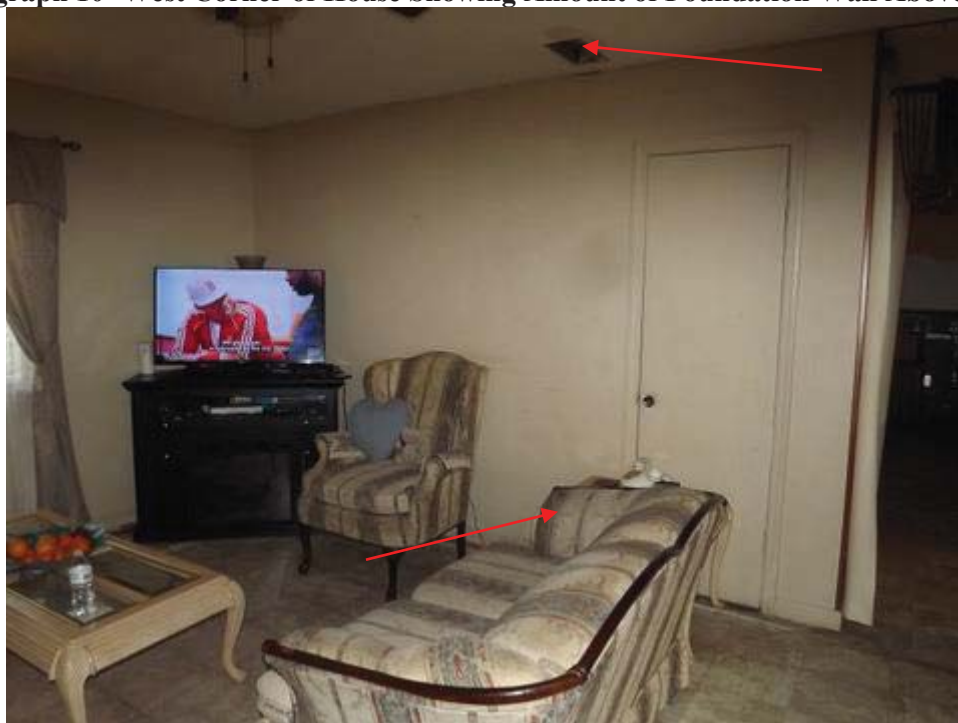
Photograph 11- Living Room with Water Stain Around Supply Diffuser in Ceiling

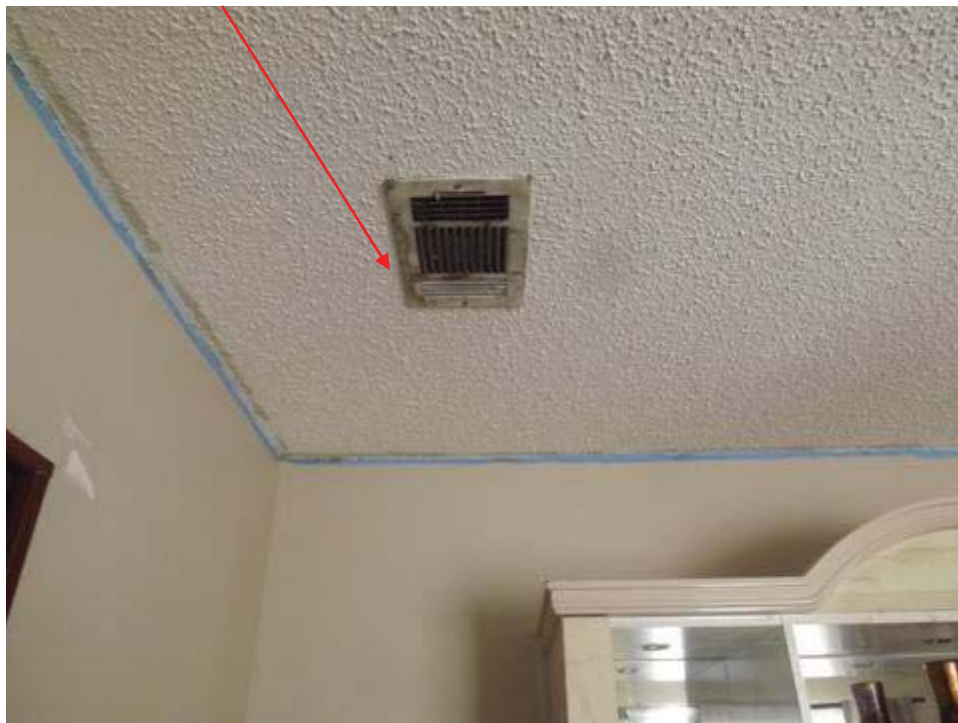
Photograph 12- Dirty/Rusted Supply Diffuser in Dining Room

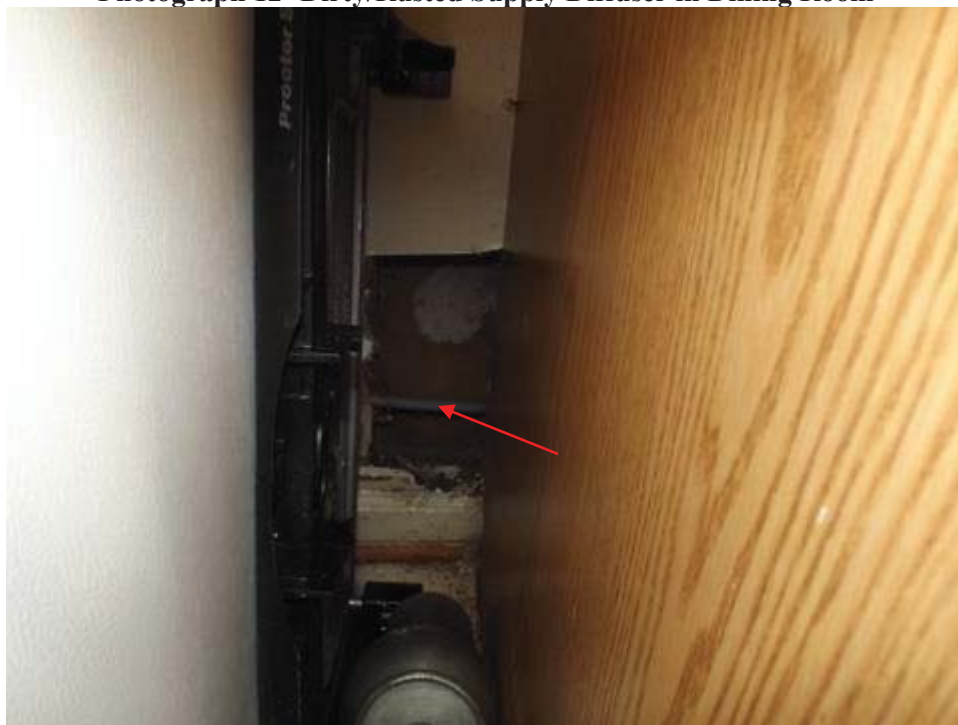
Photograph 13- View of Drywall Removed Behind Refrigerator in Kitchen with Water Line Going to Toilet Supply Line

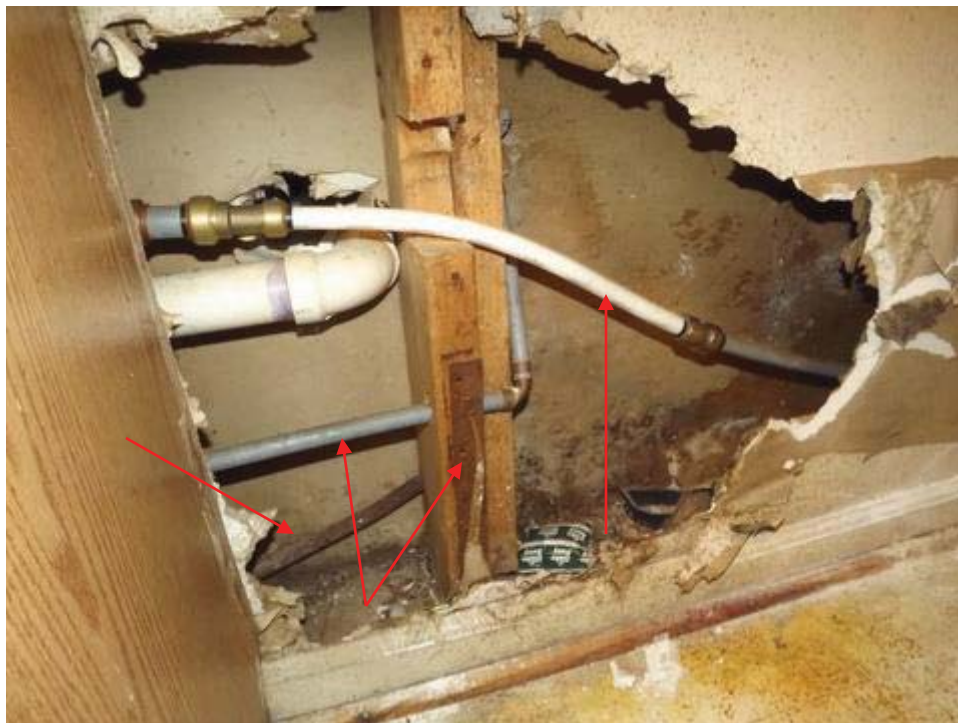
- 3) The area where the icemaker water line leak occurred was behind the refrigerator and shared a common wall with the bathroom behind the toilet and the bathroom vanity sink. The refrigerator was pulled out and revealed that the drywall had been removed (~2' x 2') to access the water lines. The original water lines were gray polybutylene with copper fittings. Polybutylene is recognized in the plumbing/building industry for pipe failure that results in water leaks. There was a mix of water supply lines used for repair behind the refrigerator and kitchen sink cabinet that included PVC and PEX connected with push type fittings. There had been a repair to the water line that was assumed to have served the refrigerator icemaker using white PVC. However, this repair did not include a valve to reconnect the icemaker to the refrigerator therefore the icemaker was not connected to a water supply at the time of this investigation. It was noted that the water line assumed to be for the icemaker also served as a supply line to the bathroom toilet and vanity sink cabinet. There was significant drywall and insect related debris on top of the sill plate in the wall cavity behind the refrigerator. There was scattered visible mold growth in the wall cavity, e.g. wall studs, sill plate and drywall, in

proximity to the PVC water line repair. The two nail plates, one still attached to the wall stud and one lying at the bottom of the wall cavity, were severely corroded indicating long-term exposure to water. This mold growth and corrosion of the nail plates in this wall cavity area would likely be from the refrigerator icemaker water line leak. It was noted that the flooring in and around the refrigerator appeared stable at the time of this evaluation indicating that water from this loss location had not caused significant water damage to the subfloor. Wood moisture meter measurements were collected from the exposed wall framing and flooring using a Protimeter SurveyMaster Model POL 5386 Dual Function Moisture Meter. Moisture meter measurements were taken with the Heavy Duty Moisture Probe whereby the metal electrode tips are pushed into the wood surface and the percent moisture content (%MC) of the wood is measured. The range of measurements for the pin probe are as follows: 7-16.9% Dry, 17-19.9% At Risk, 20-99.9% Wet. The Search Mode (REL) was also used to detect moisture in relative terms up to $\frac{3}{4}$ of inch beneath the surface of the vinyl flooring regardless of surface moisture, e.g. condensation, which has little effect on readings. Therefore, technically the REL measurement would detect moisture within the wood subfloor beneath the vinyl flooring. The ranges of measurements for the REL mode are as follows: 70-169 Dry, 170-199 At Risk, 199-999 Wet. Moisture meter measurements using the pin probe taken from the wall framing and drywall behind the refrigerator, from the drywall behind the kitchen sink and from the base of the kitchen sink cabinet measured dry during this investigation. Moisture meter readings collected using the scan mode from the flooring in and around the refrigerator and out in front of the kitchen sink cabinet measured dry during this investigation. Please see the photographs in Attachment I for details of these observations and moisture meter measurements.

Photograph 14- White PVC Water Line Repair for Icemaker- Note: This Cold Water Line Services the Toilet Supply and Bathroom Vanity Sink. Original Polybutylene Plumbing Shown with Corroded Nail Plate on Wall Stud and Loose Nail Plate in Wall Cavity Below

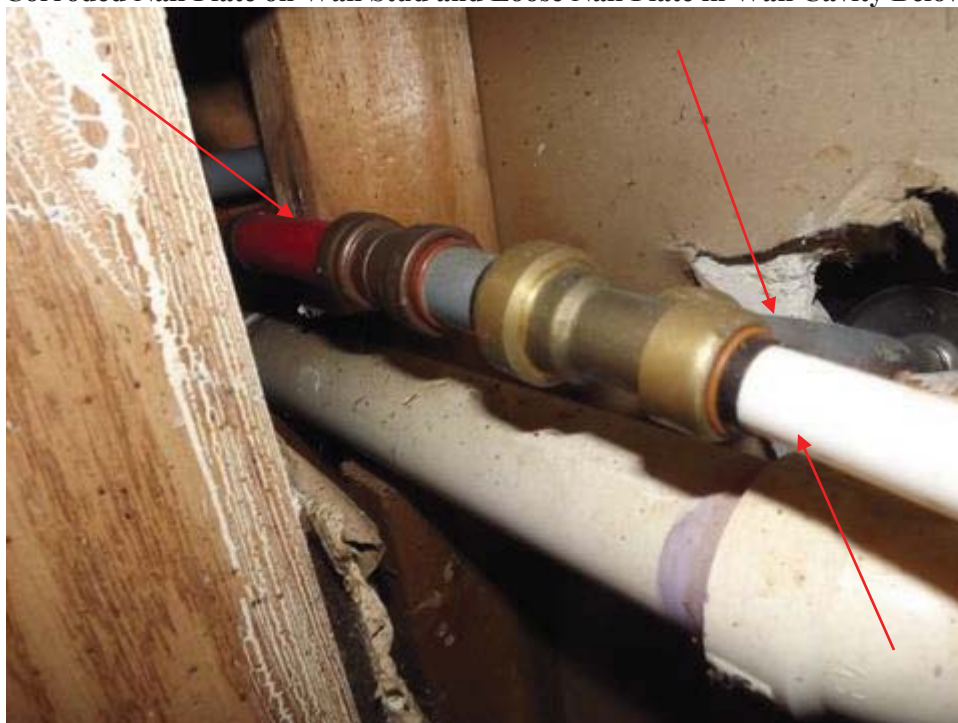
Photograph 15- Closer View of Repair Shown in Photo 14 from Behind Bathroom Vanity Sink (Gray Pipe to Sink)- Note: Red Pex Repair to Left

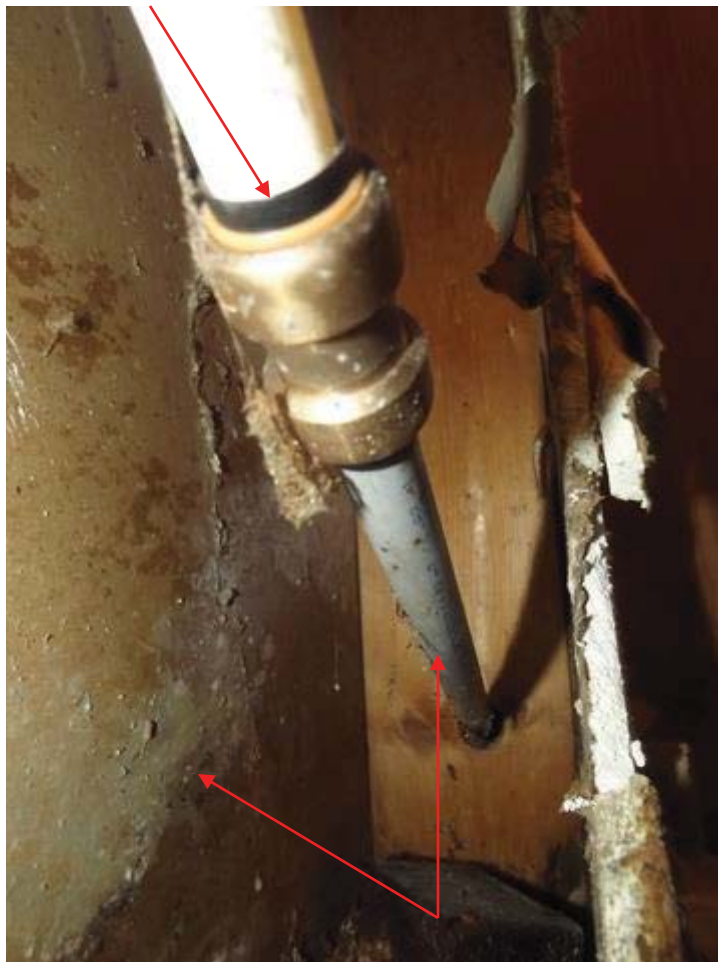
Photograph 16- Side View of Repair From Photo 14 Looking in Direction Toward Toilet Supply Line- Note Mold Growth on Back of Drywall

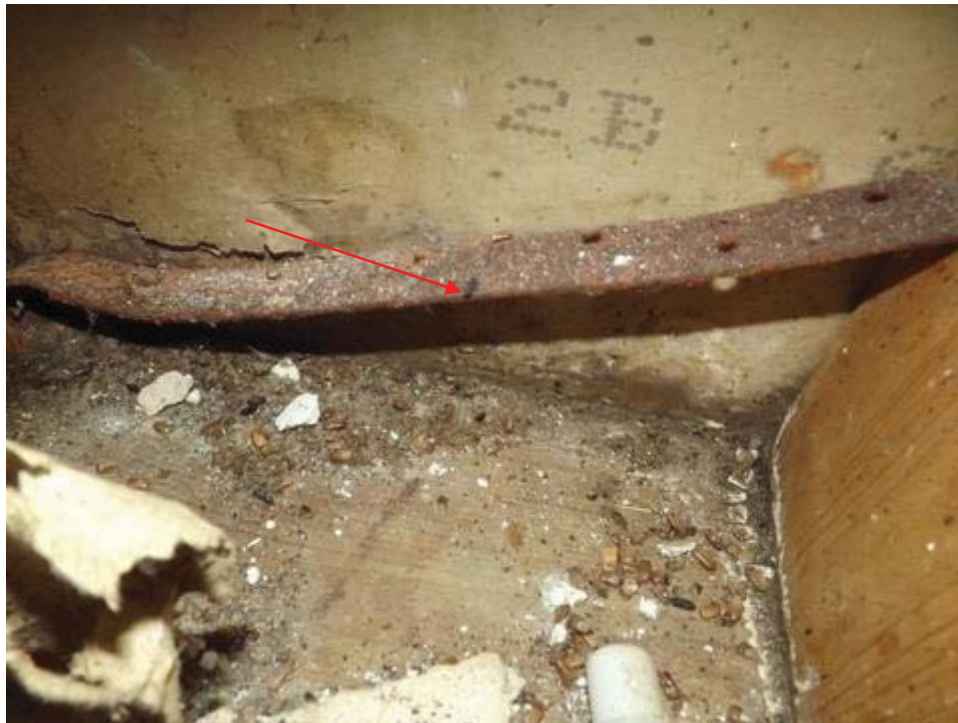
Photograph 17- Closer View of Nail Plate Shown in Photo 14 with Debris on Sill Plate

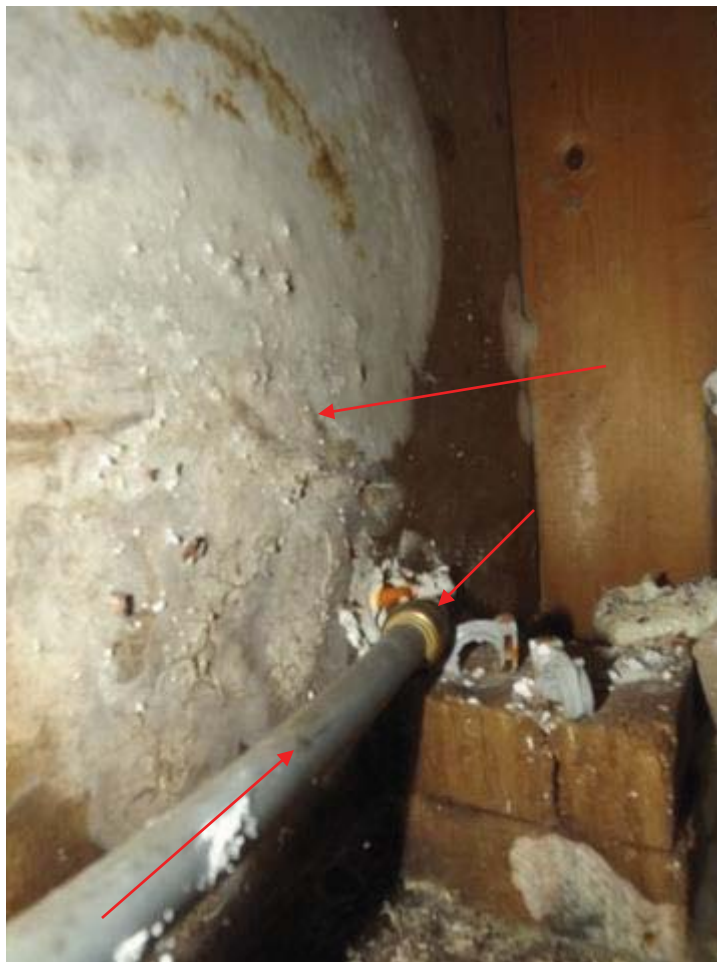
- 4) The toilet water supply line leak appeared to have occurred at or near the place where the water line went through the drywall penetration into the bathroom. The repair had been made with approximately 5" to 6" of blue PEX that was protruding out of the wall behind the toilet. There was visible mold growth on the backside of the drywall above the area where the toilet water supply line was located and on the baseboard beneath this location that was likely caused by this loss. The floor at the back of the toilet had failed due to long-term water exposure that resulted in the failure/rot of the OSB subfloor. The current deflection of the floor on either side of the toilet measured from the level floor was 1.5" to 2". The toilet base had wedges installed between it and the floor to keep it stable. The toilet did not rock indicating that it was seated on the wax ring. Inspection from the underside of the toilet found that the drain line was placed next to a floor joist and was secured with wood block and metal strap. Moisture meter readings from behind the toilet measured dry at the time of this evaluation. However, the moisture meter readings out in front and to the right of the toilet running toward the bathtub measured wet approximately 2' to 2.5' out from this fixture. These wet moisture meter measurements in front of the toilet would indicate that there might be a leak from the toilet wax ring seal.

Photograph 18- View of Toilet Supply Line Where It Exits to Bathroom with Visible Mold Growth Cased By Loss At This Location

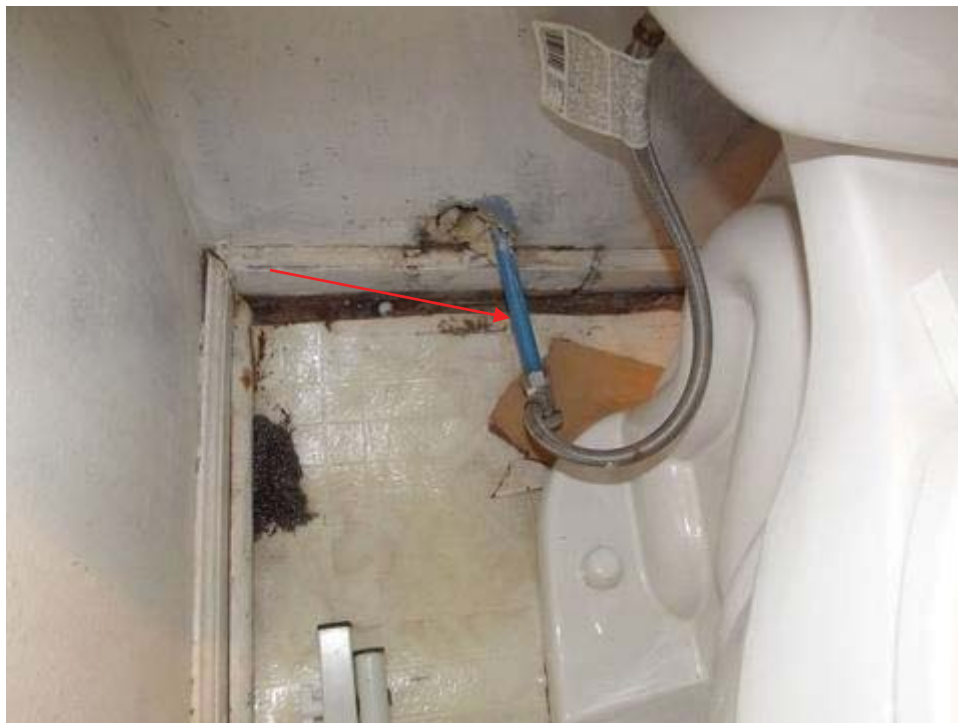
Photograph 19- View of PEX Repair to Toilet Supply Line in Bathroom

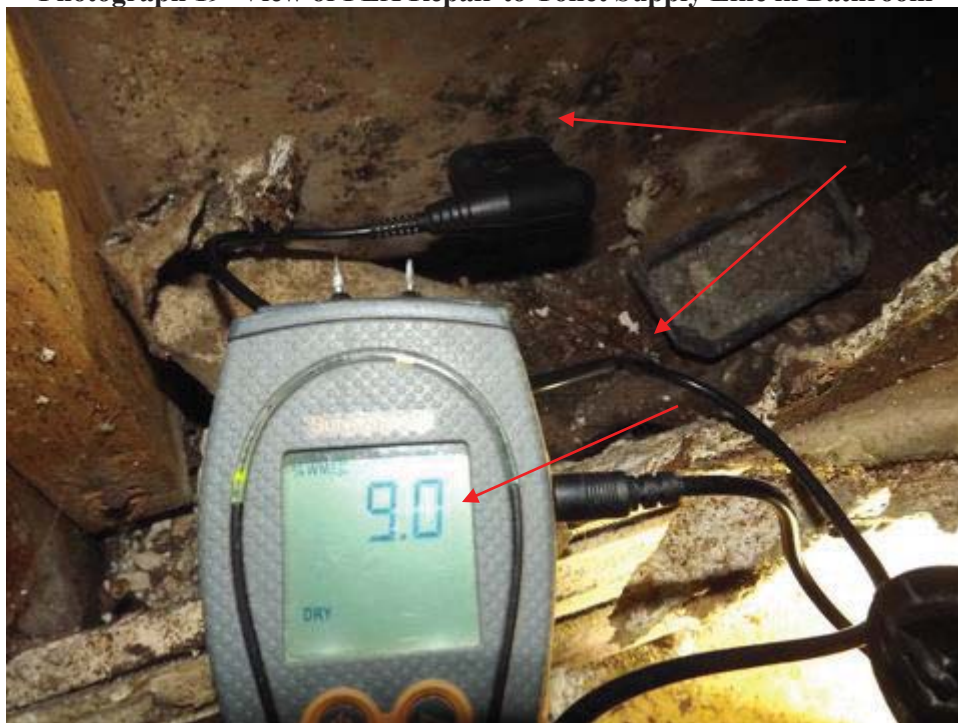
Photograph 20- Example of Dry Moisture Meter Reading from Drywall in Wall Cavity Beneath Icemaker Repair with Visible Mold Growth and Debris

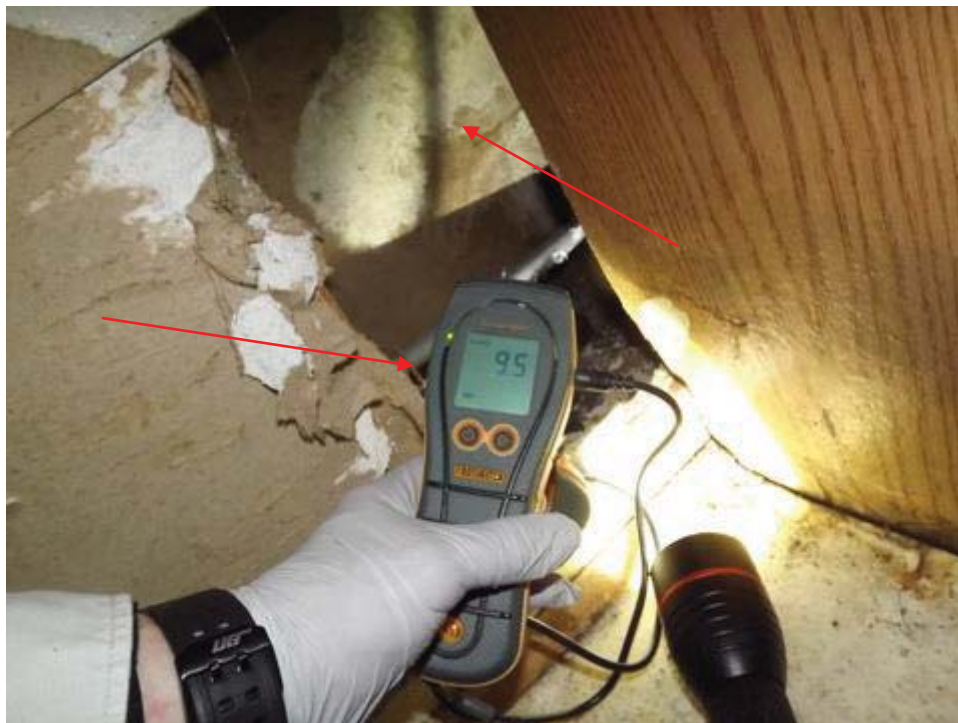
Photograph 21- Dry Moisture Meter Reading From Wall Cavity Beneath Toilet Water Supply Line with Visible Mold Growth Above

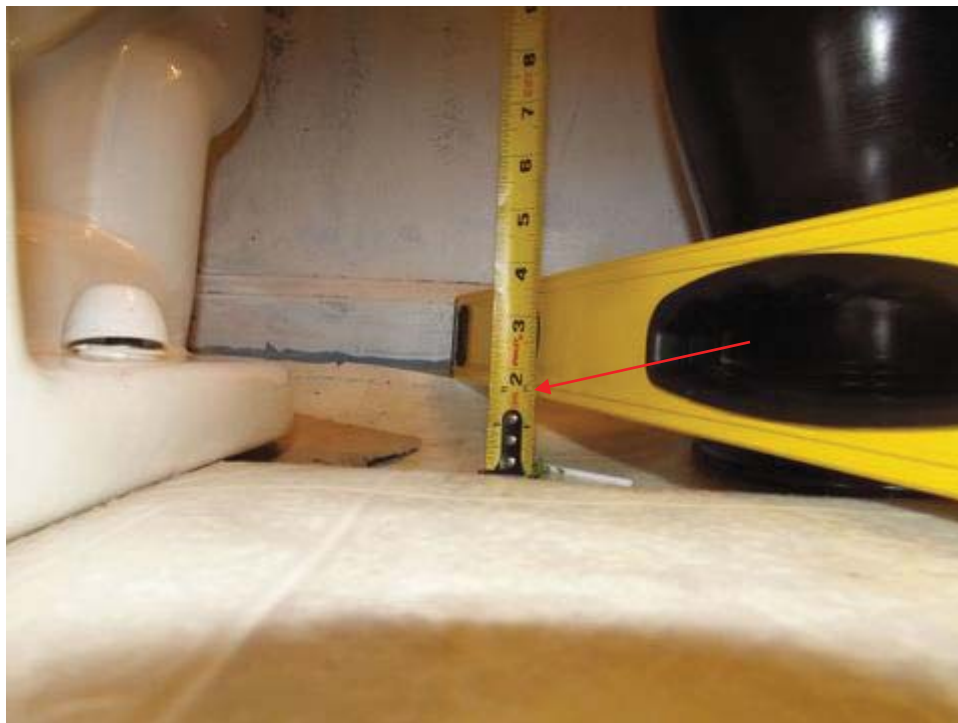
Photograph 29- 1.5 " Deflection in Floor to Right and Behind Toilet Base

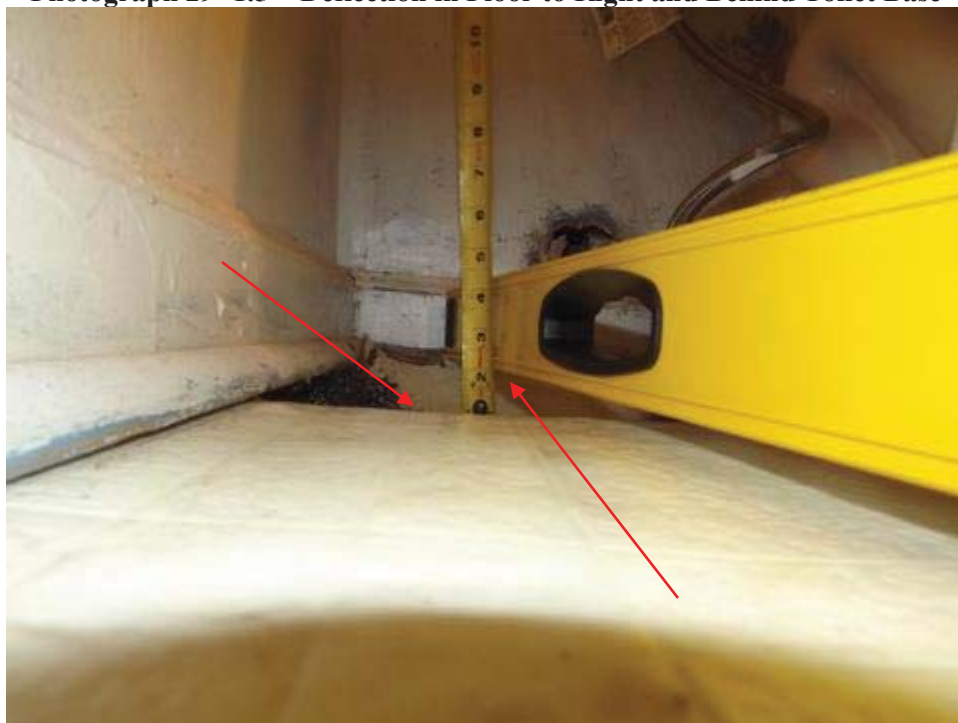
Photograph 30- 2.0" Deflection in Floor to Left and Behind Toilet Base

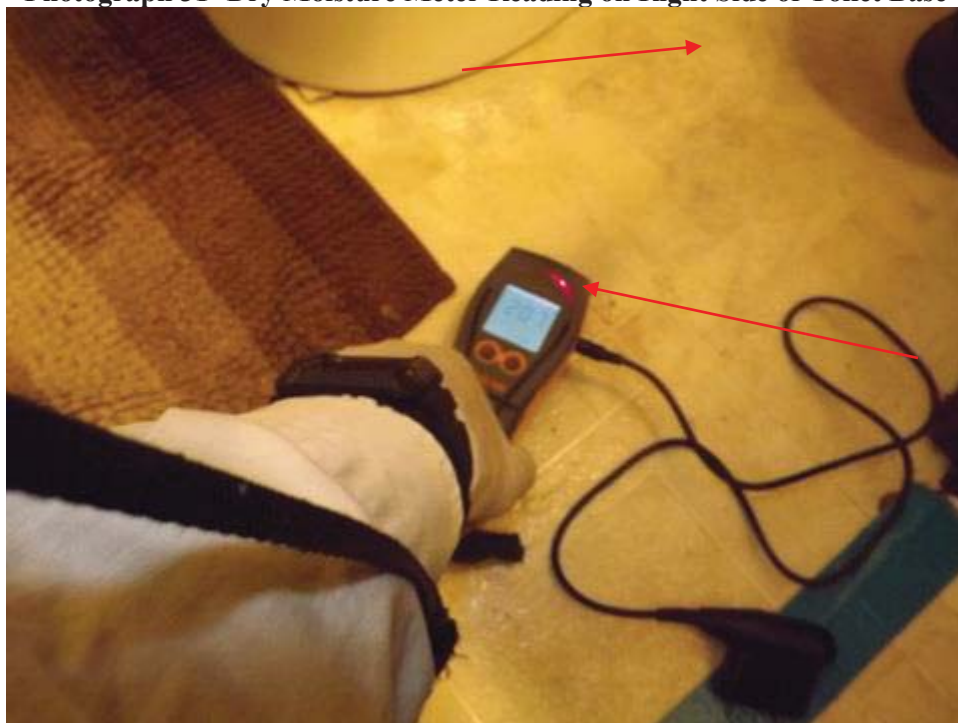
Photograph 32- Wet Moisture Meter Reading on Right Side of Toilet Base Approximately 12" from Location Shown in Photo 31

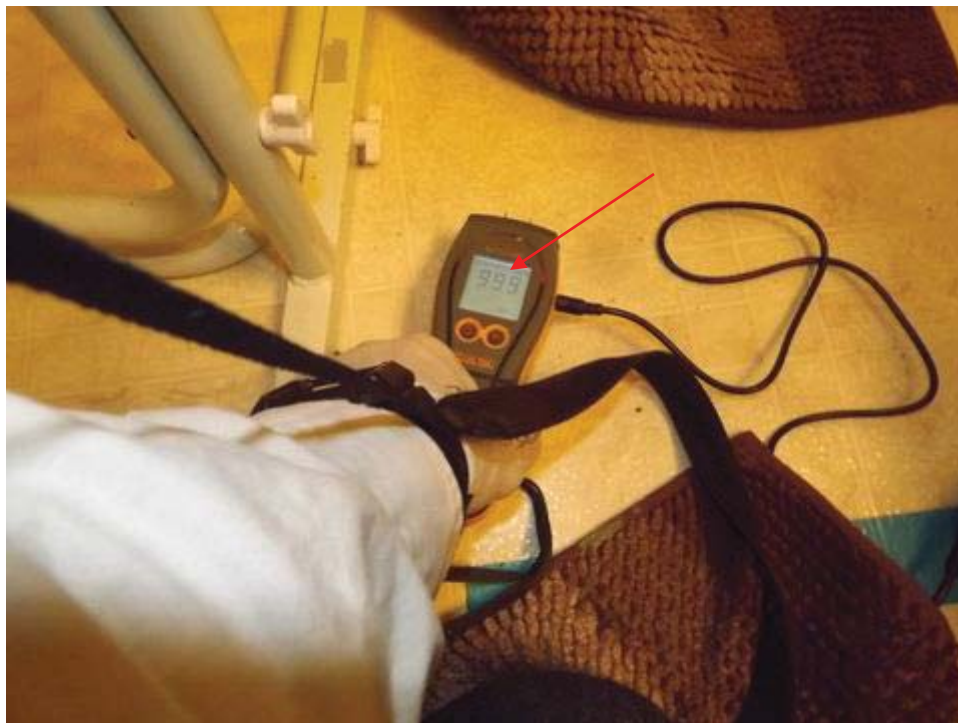
Photograph 33- Example of Wet Moisture Meter Reading Approximately 12" from Measurement Location in Photo 32

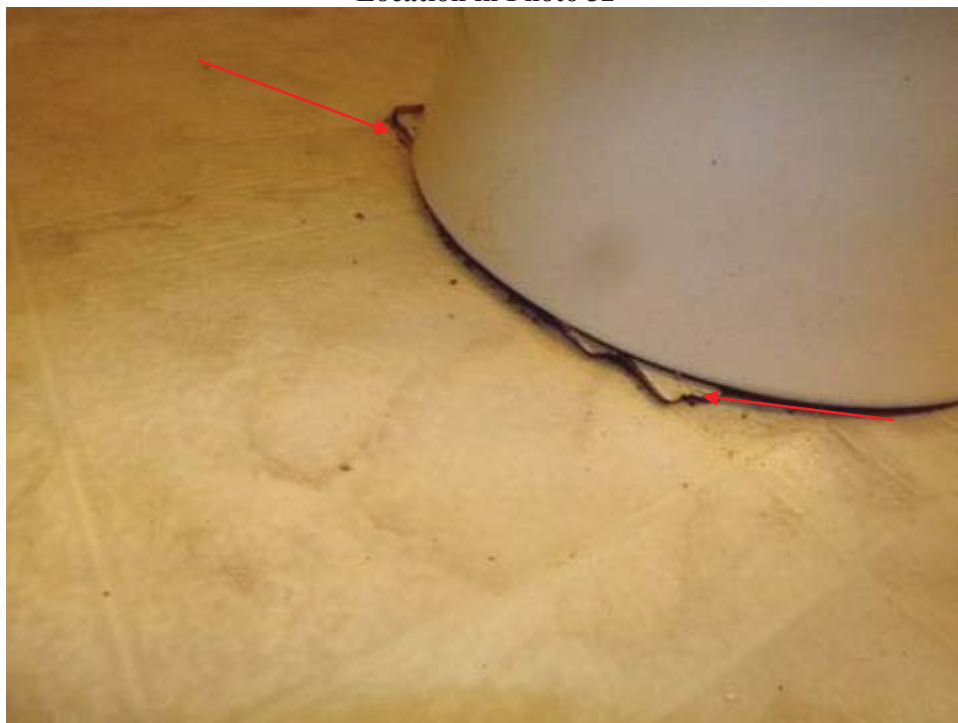
Photograph 34- Wedges Under Front of Toilet Base

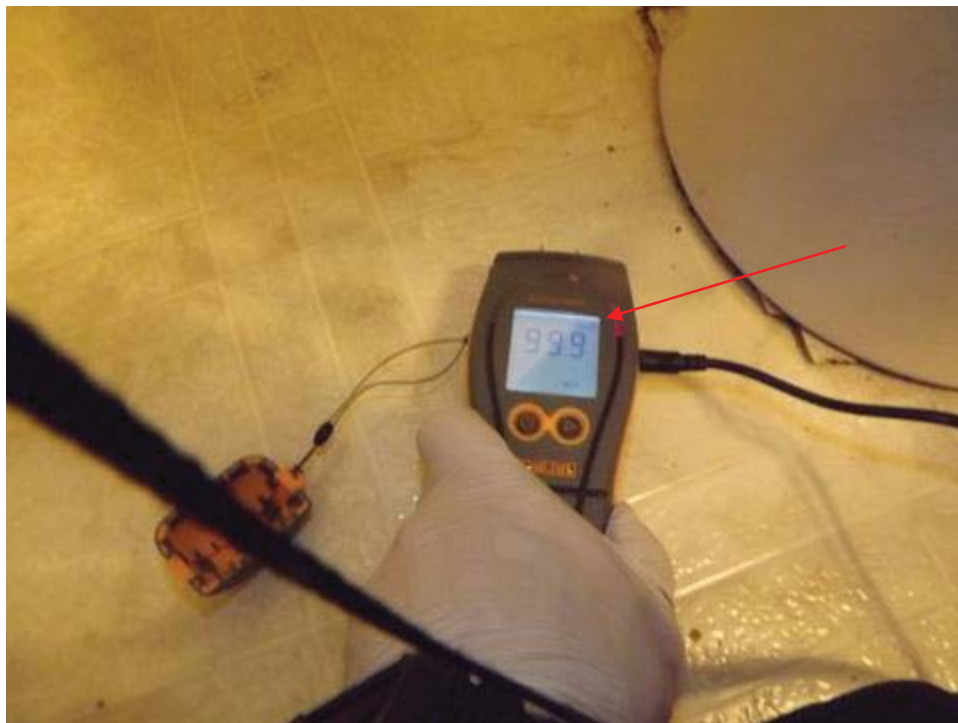
Photograph 35- Wet Moisture Meter Reading in Front of Toilet Base

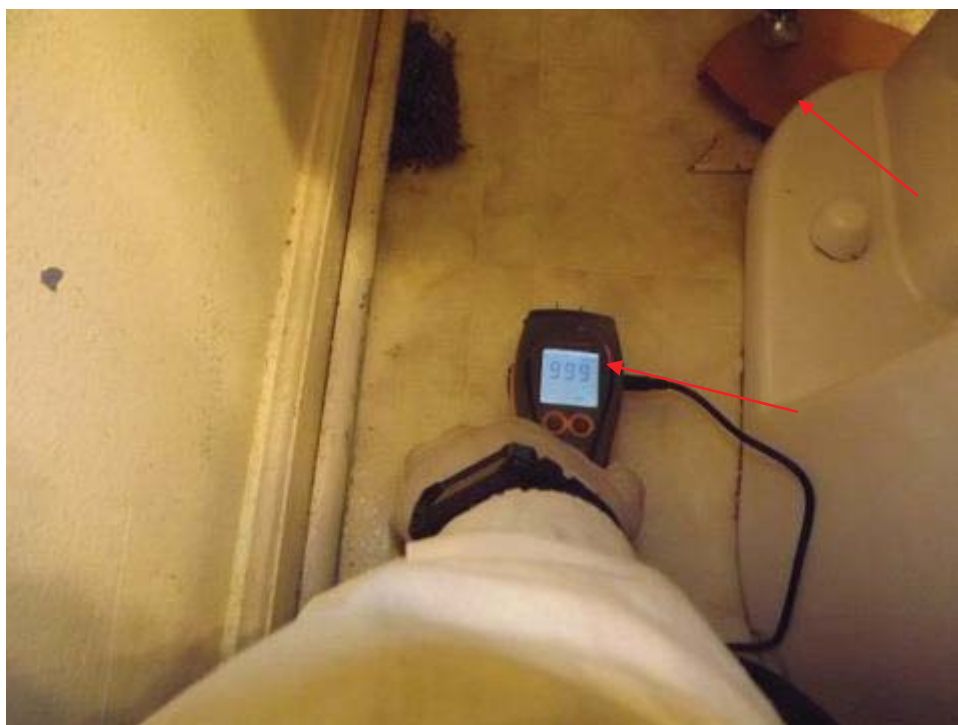
Photograph 36- Wet Moisture Meter Reading on Left Side of Toilet Base with Wedge Beneath Back of Toilet Base

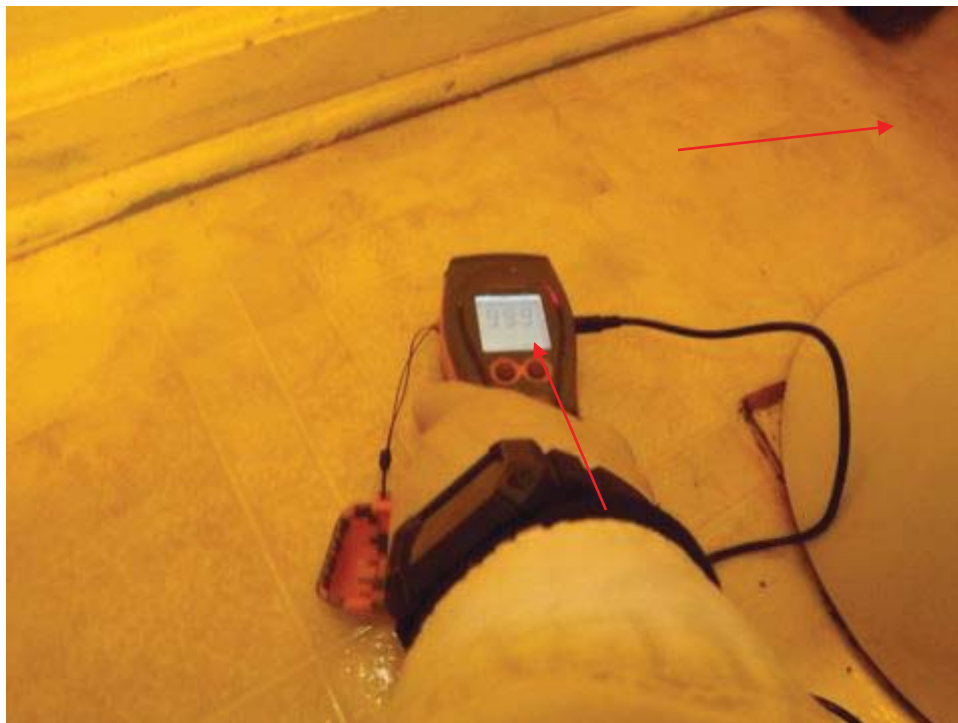
Photograph 37- Wet Moisture Meter Reading To Left (Front) Approximately 1.5" from Location in Photo 36

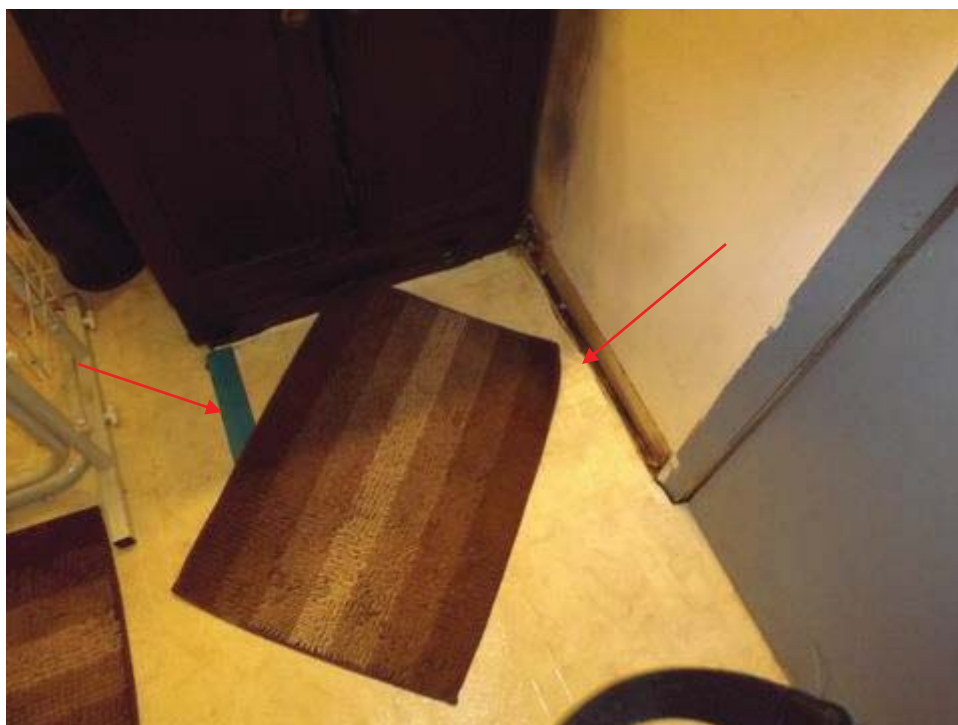
Photograph 38- Loose Vinyl Flooring in Front of Bathroom Vanity Sink Cabinet with Blue Tape Repair

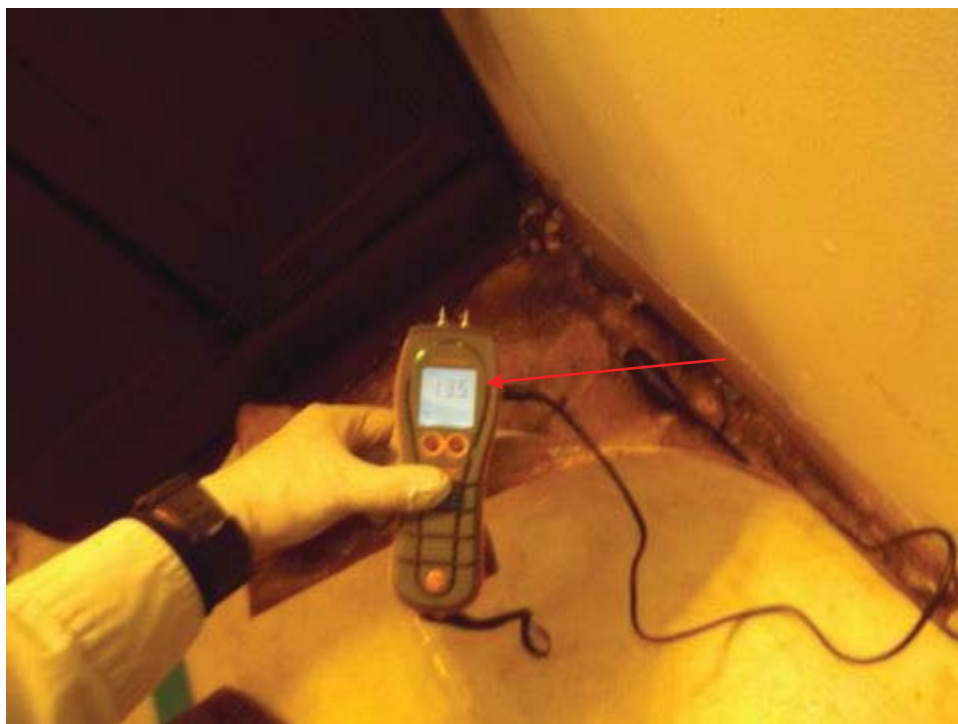
The vinyl flooring in front of the bathroom vanity sink cabinet could be pulled back to inspect the conditions beneath it. There was visible wood delamination/rot of the subfloor indicating that this area of flooring had been subject to long term moisture possibly due to a water leak from the cold water line serving this vanity sink cabinet as discussed in Section 3 of this report. Please see the photographs in Attachment I for details of these observations and moisture meter measurements.

Photograph 39- Dry Moisture Meter Reading from Water Damaged Subfloor In Front of Bathroom Vanity Sink Cabinet
